CERTIFICATE OF APPROPRIATENESS

Property: 1610 Cortlandt Street, tract 15A and 16A, block 115, Houston Heights Subdivision. The property includes a 3,989 square foot residence situated on an 8,246 square foot (62' x 133') interior lot.

Proposal: Alteration – Revisions related to exceeding the scope of work for a COA for an addition that was granted September 5, 2013 by Planning Commission Appeal. The applicant made the following deviations from their approved scope of work during construction:

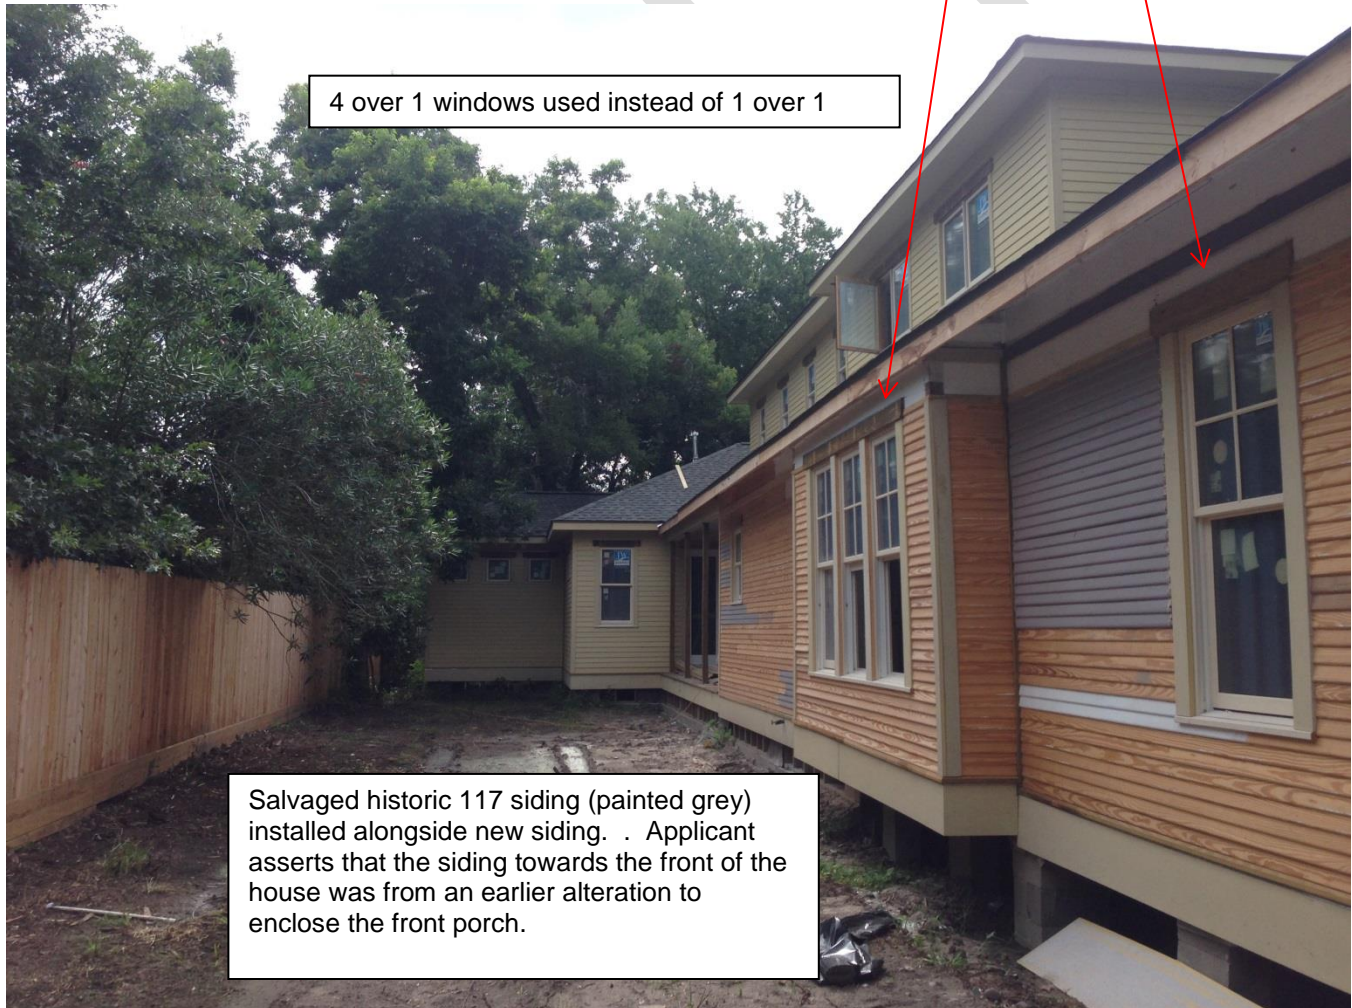
NEW SIDING AND 4 OVER 1 WINDOWS INSTALLED

4 over 1 windows used instead of 1 over 1

Salvaged historic 117 siding (painted grey) installed alongside new siding. . Applicant asserts that the siding towards the front of the house was from an earlier alteration to enclose the front porch.

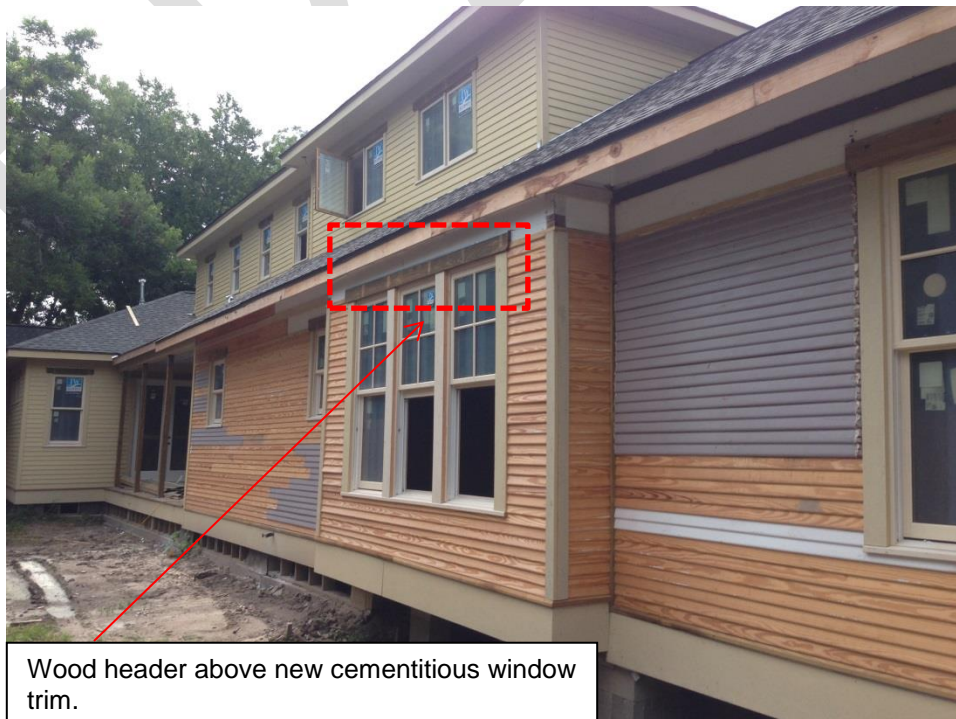
STAFF SITE VISIT PHOTO 7/21/14

Wood header above new cementitious window trim.

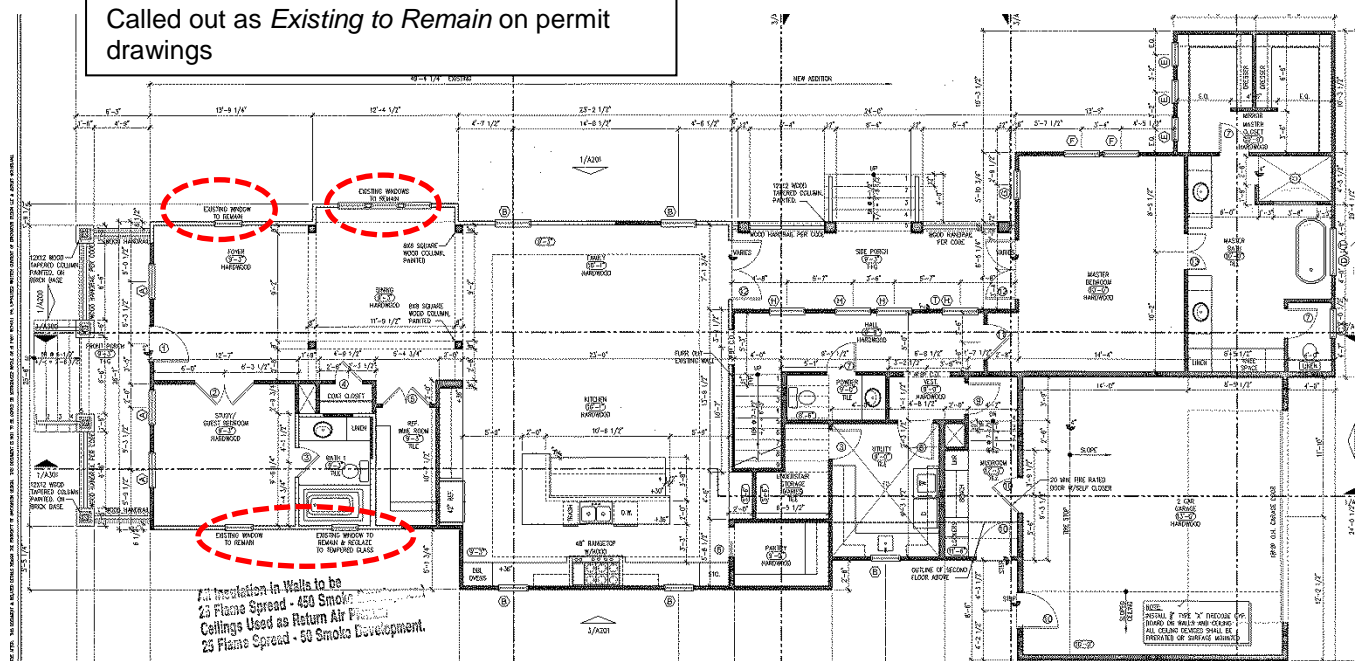
FIRST FLOOR PLAN

Called out as *Existing to Remain* on permit drawings

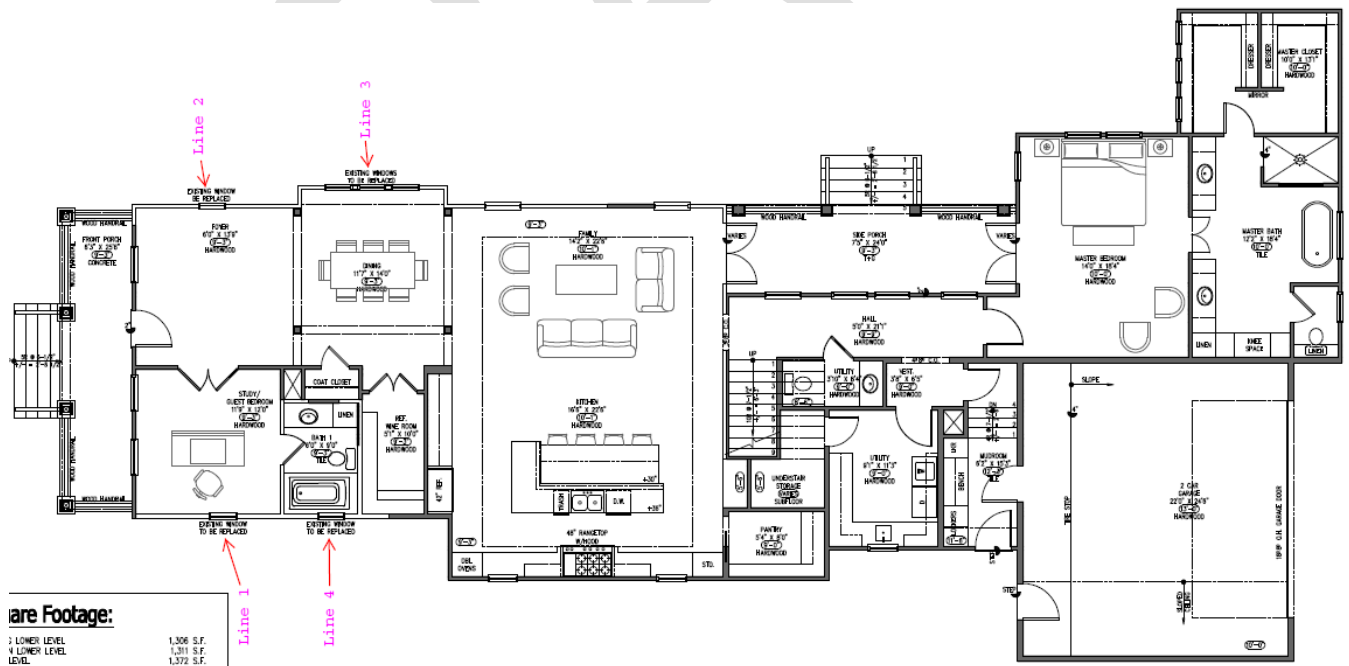
NEW 4 OVER 1 WINDOWS INSTALLED

Windows/Doors: The applicant was approved to retain six existing 1 over 1 windows on the historic portion of the existing house. The applicant has since replaced these windows with five new 4 over 1 wood windows and one 1 over 1 wood window. Photos provided by the Structural Inspector and the applicant indicate that these windows were non-original metal sash windows.

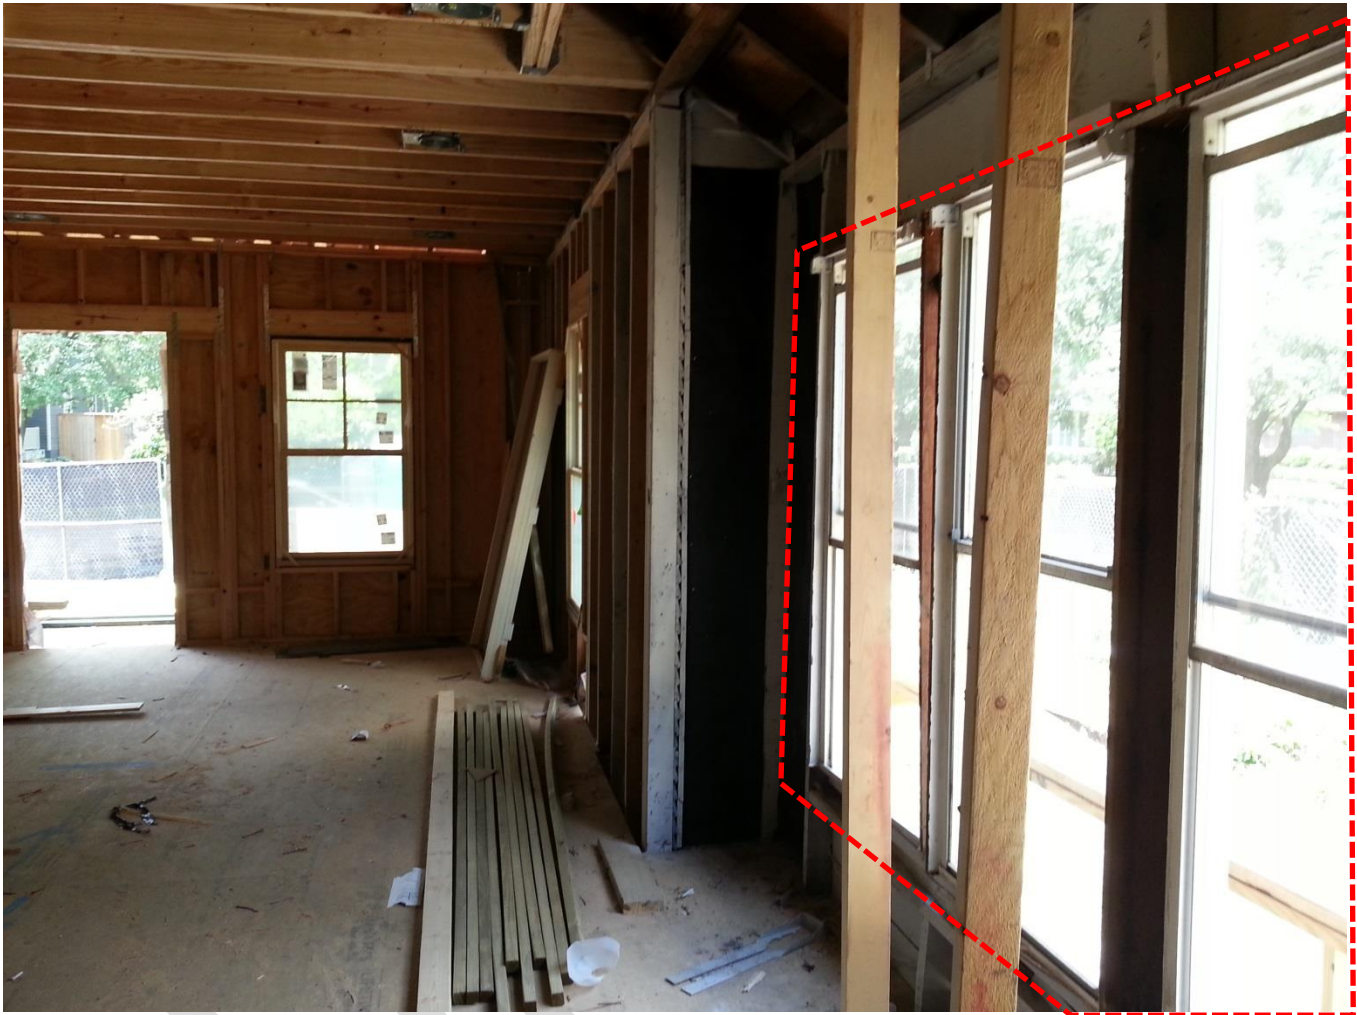
PHOTO OF EXISTING WINDOWS DURING CONSTRUCTION TAKEN 5/6/14

THESE APPEAR TO BE NON-ORIGINAL METAL WINDOWS

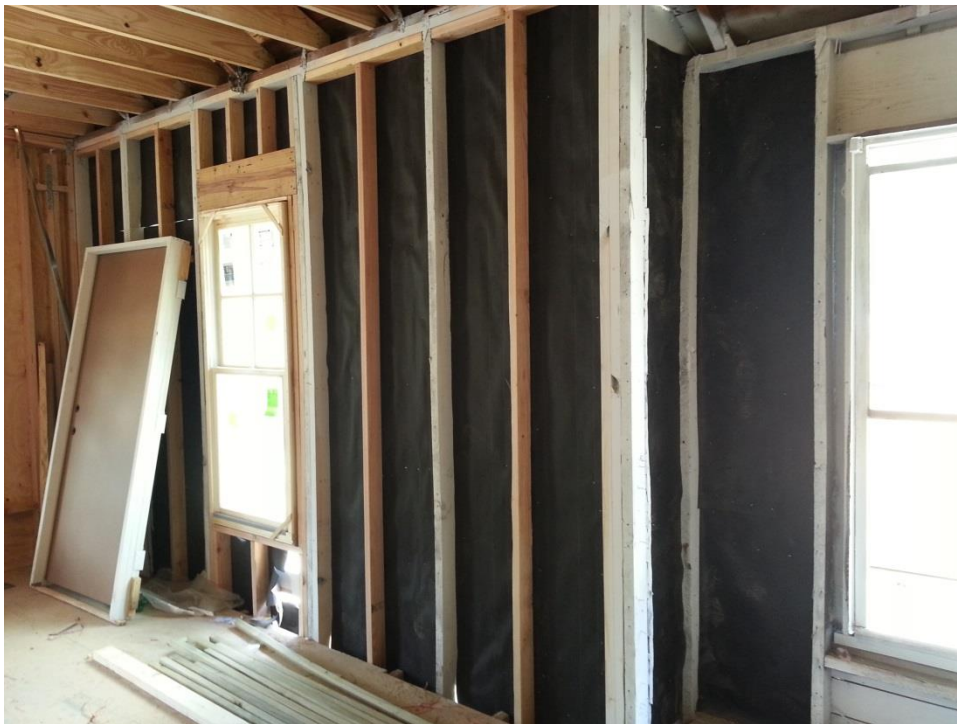
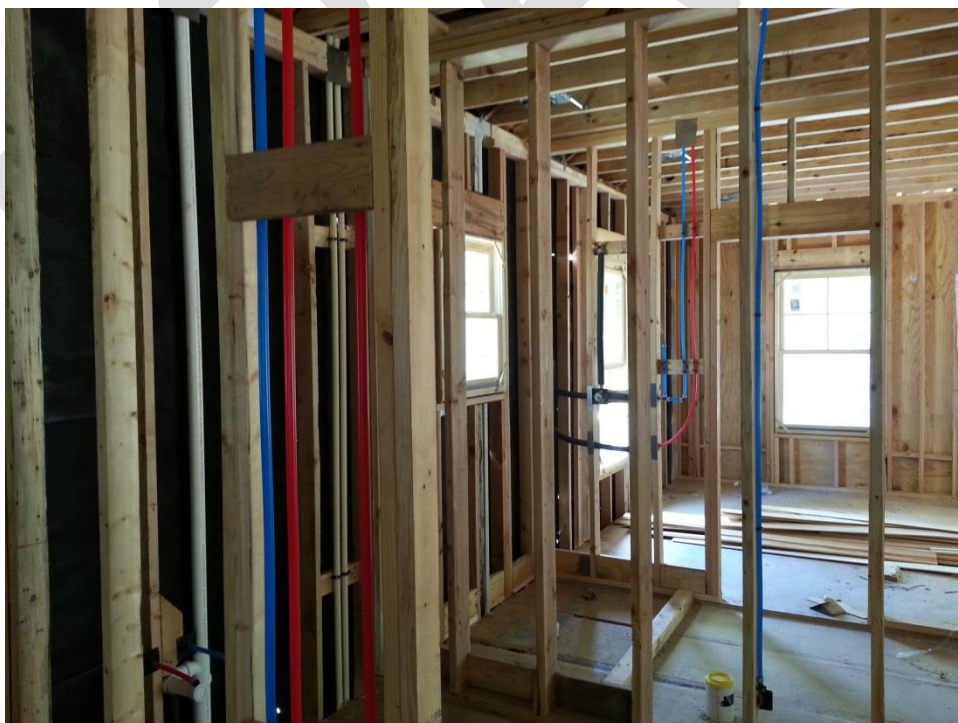
INSPECTOR PHOTOS OF MISSING SHIPLAP TAKEN 5/6/14

Photos from a site inspection performed on May 6, 2014 show that the applicant removed the house's structural shiplap. The applicant asserts that the structural wall material was heavily deteriorated and needed to be replaced. The applicant replaced the shiplap with plywood.
